Portage Creek Sediment Remediation Project Kalamazoo, Michigan

Post-Sediment Removal Structure Feature Assessment Removal Area SA5-A

FLEIS & VANDENBRINK
ENGINEERING, INC.

August, 2013

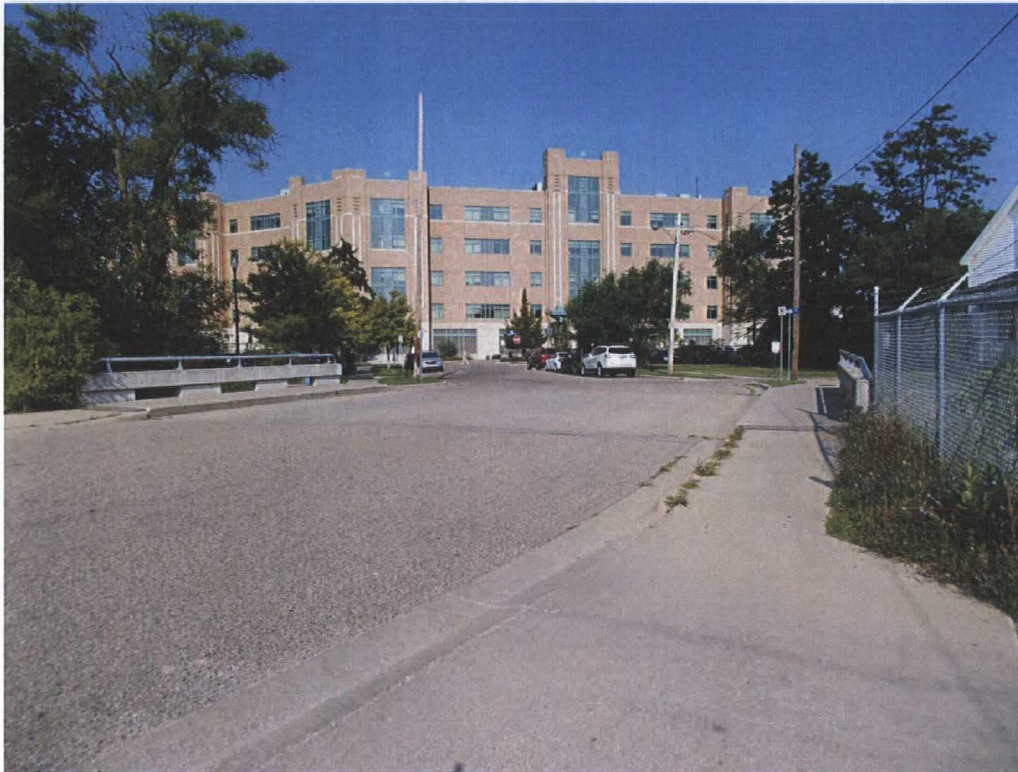
Structure viewed from the northeast approach area

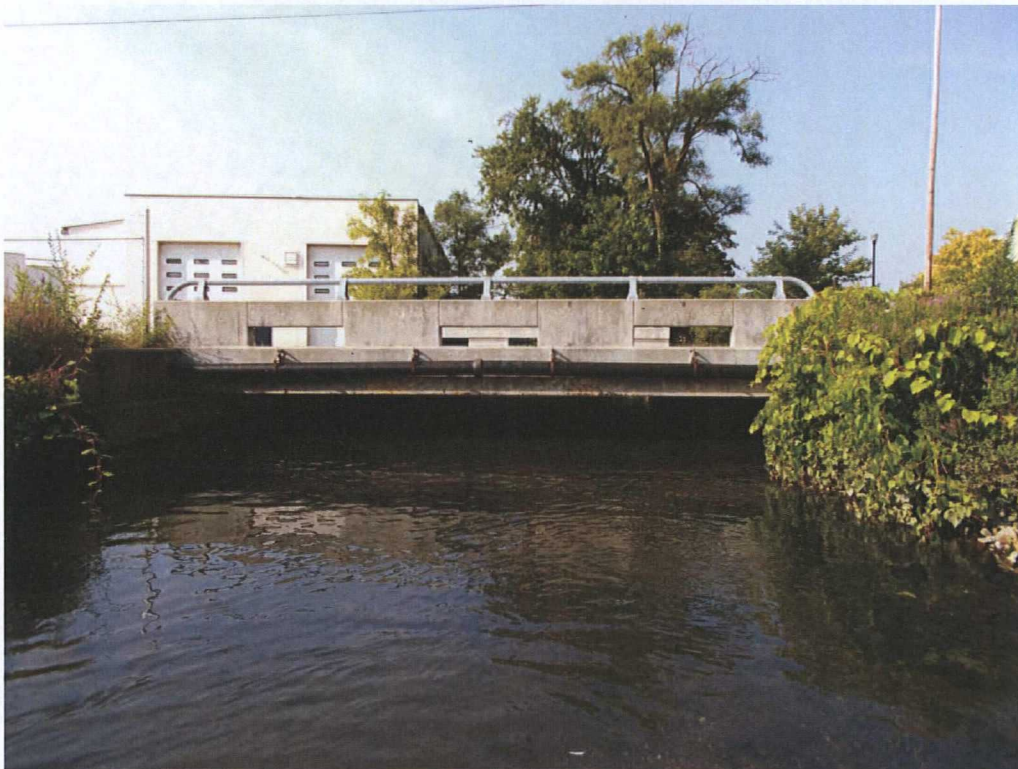
Elevation view of the structure looking south

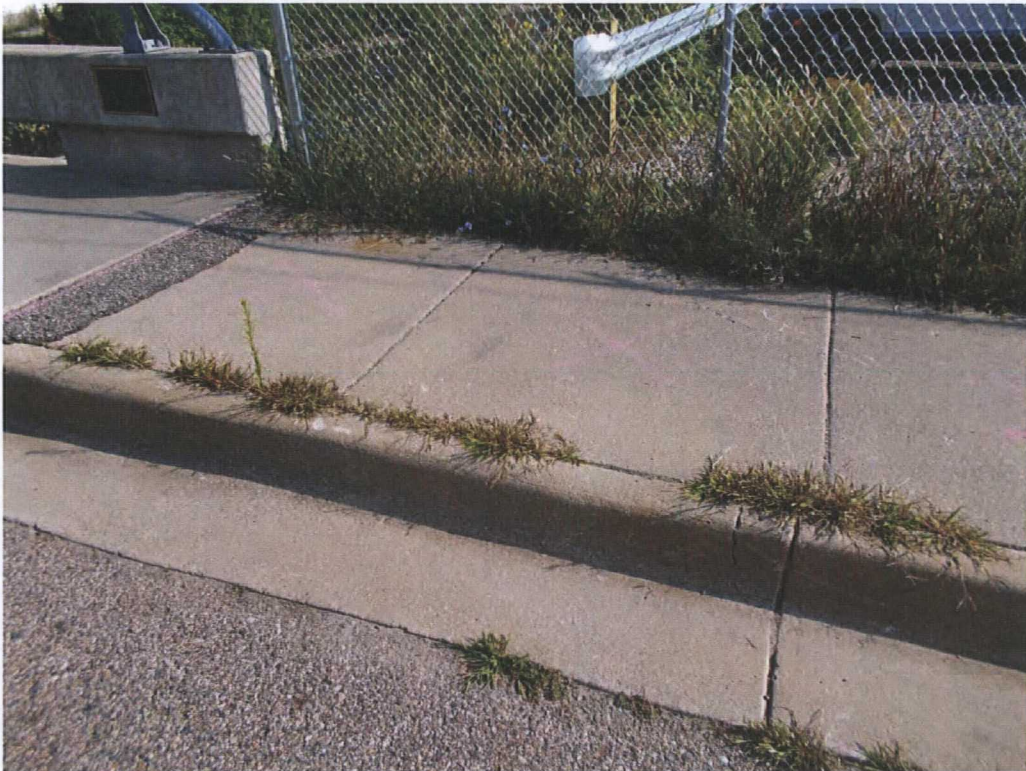
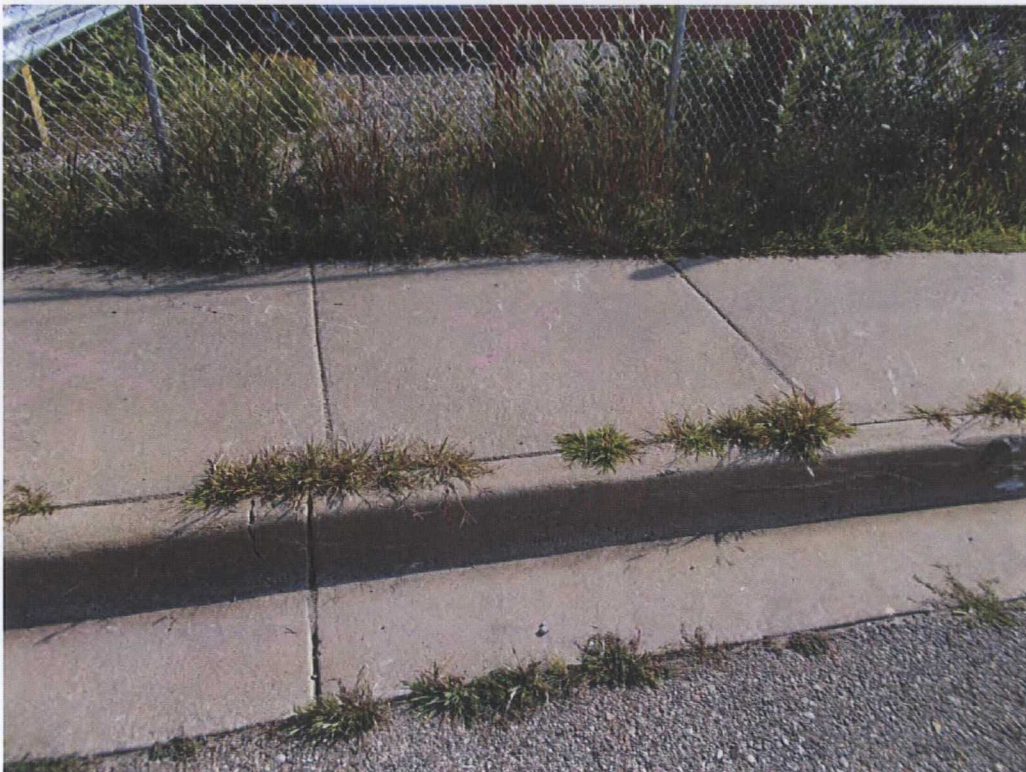
- There are several cracked sections of concrete sidewalk in the northeast approach. The scratches on the surface appear to indicate the damage is related to sediment removal. Three sections appear to be marked for replacement, which is recommended.
- Aside from the sidewalk, the structure does not appear to have been impacted during sediment removal.

Cracked sidewalk in the northeast apparently painted for removal

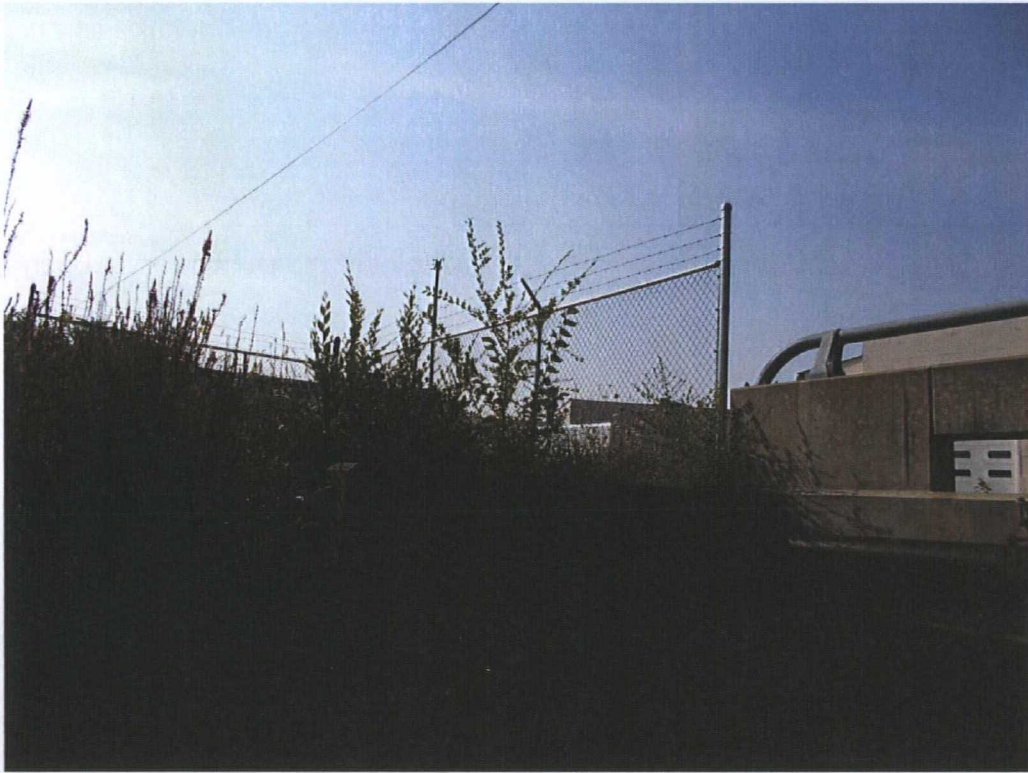
View of fence at Dutton Street from the channel

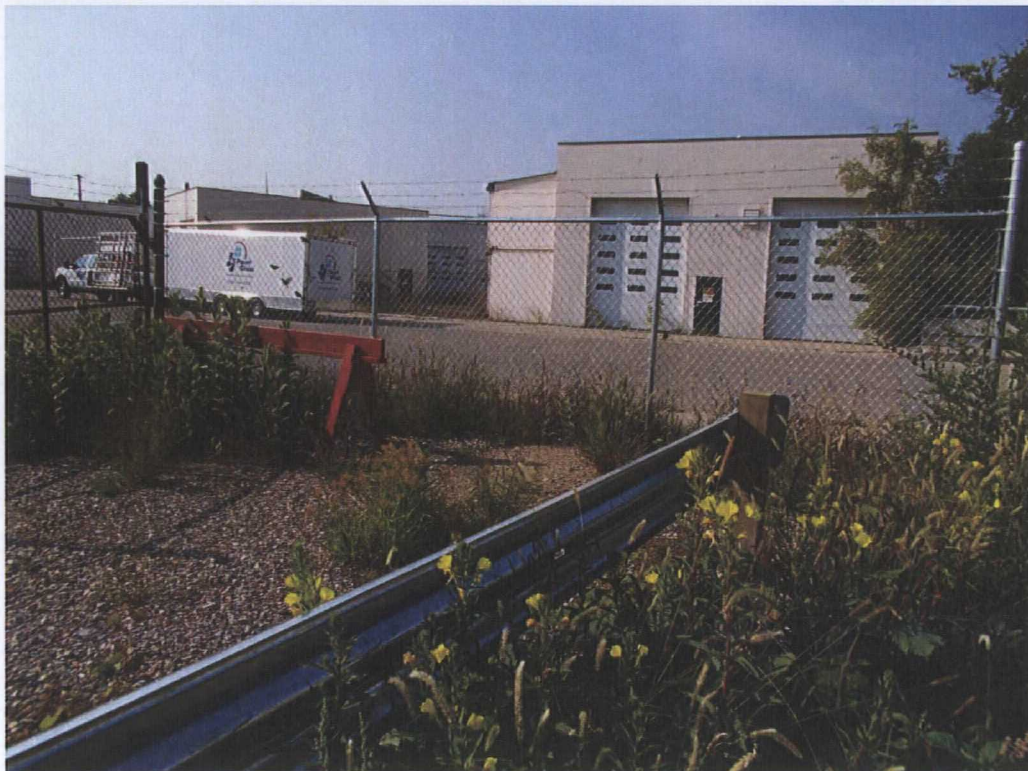
- Several sections of fence at the northeast quadrant of the Dutton Street Bridge have been replaced.
- The fence along the top of bank has been removed and replaced with Type A guardrail. Assuming this was negotiated with the property owner, no additional action is recommended.

View of replaced sections of fence along Dutton Street

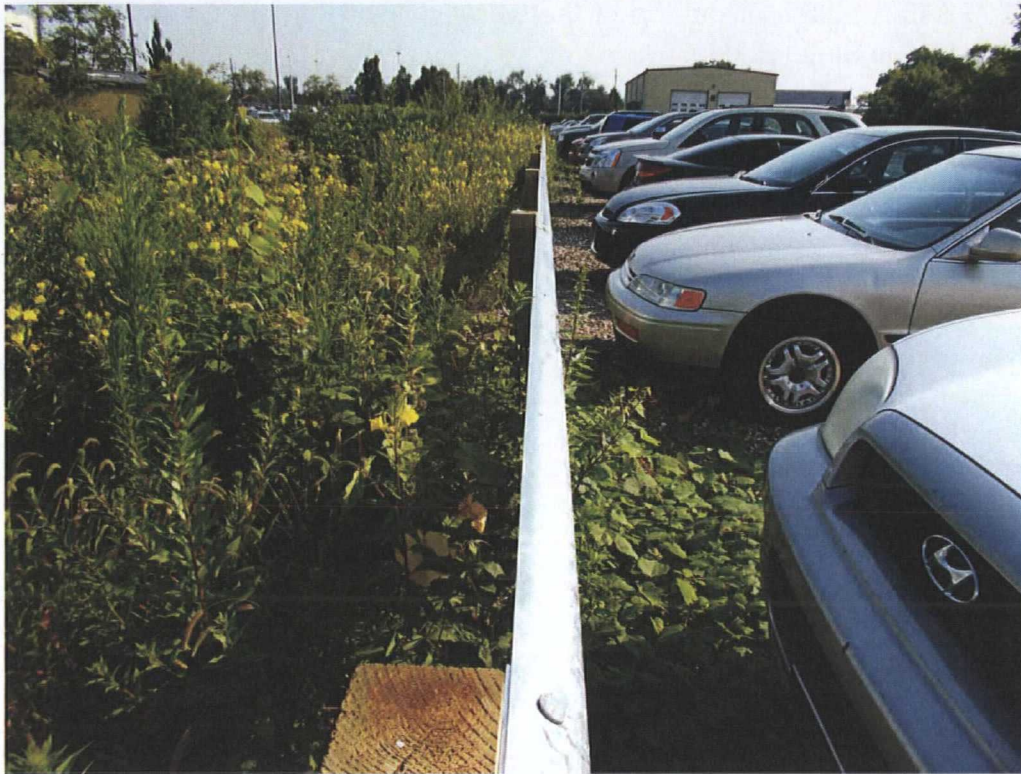
View of new Type A guardrail along top of bank

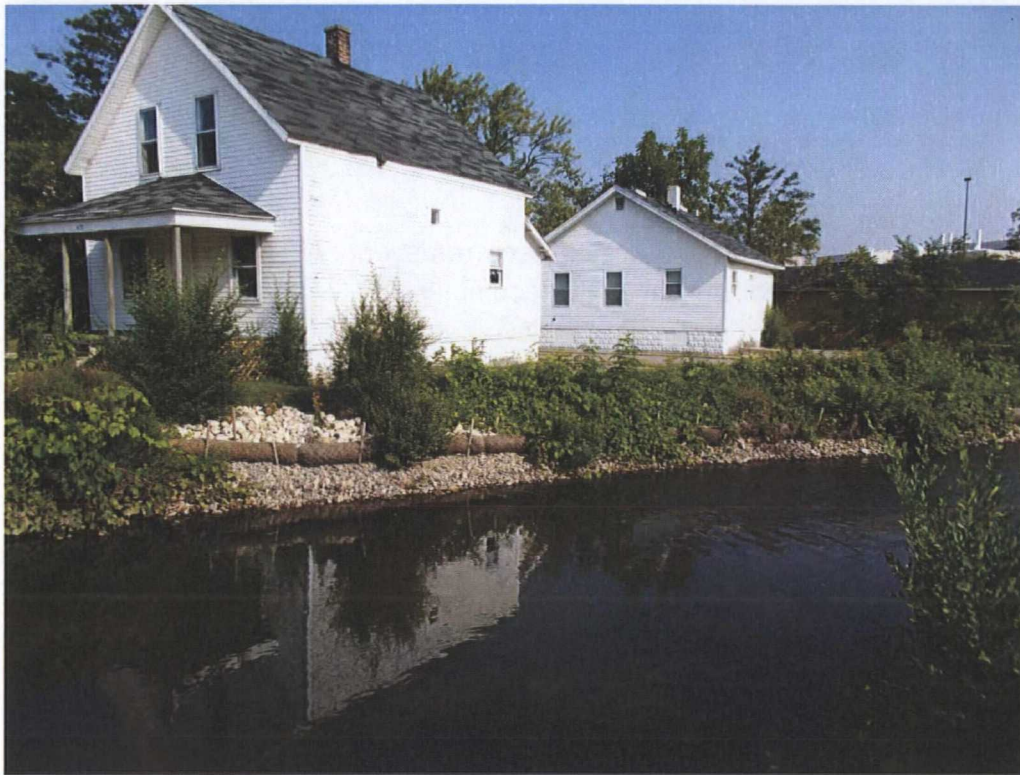
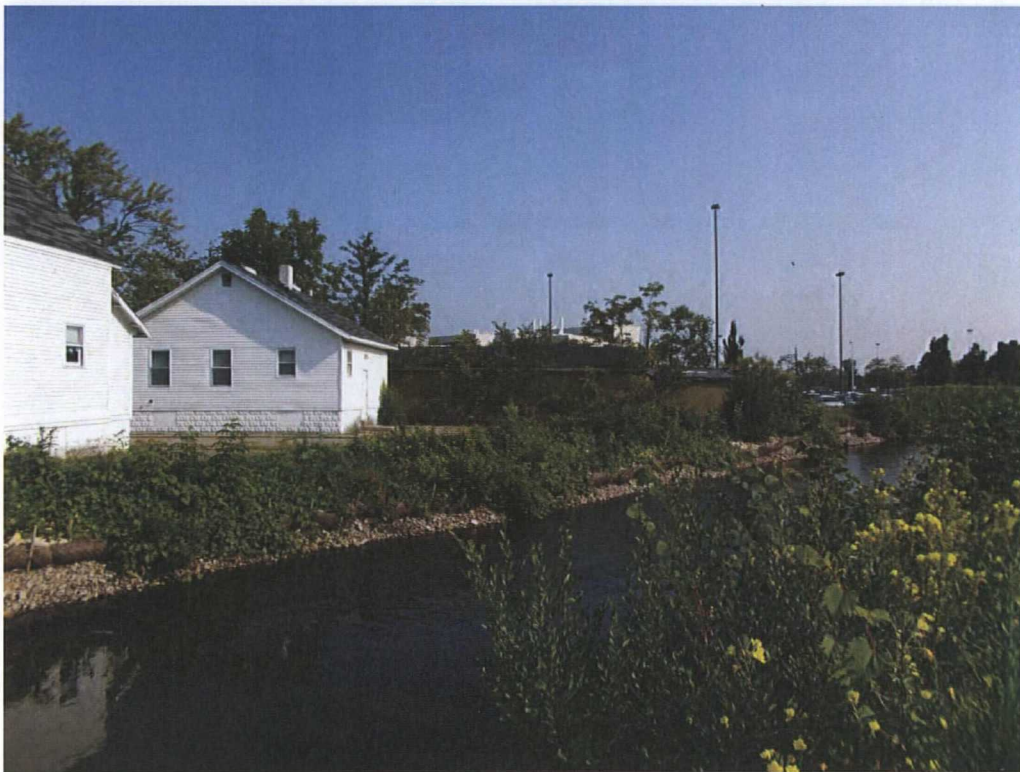
- The fencing has been removed. Assuming this is acceptable to the property owner, no additional action is recommended.

View of the west bank in the area of the previous fencing

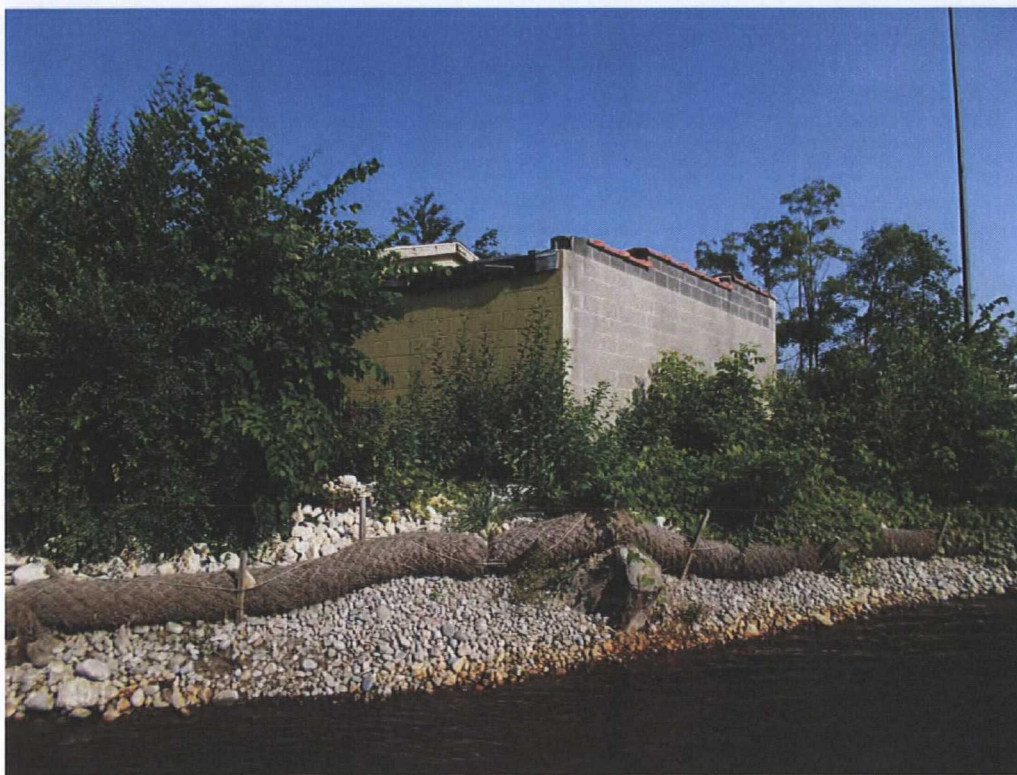
View of the structure from the upstream channel

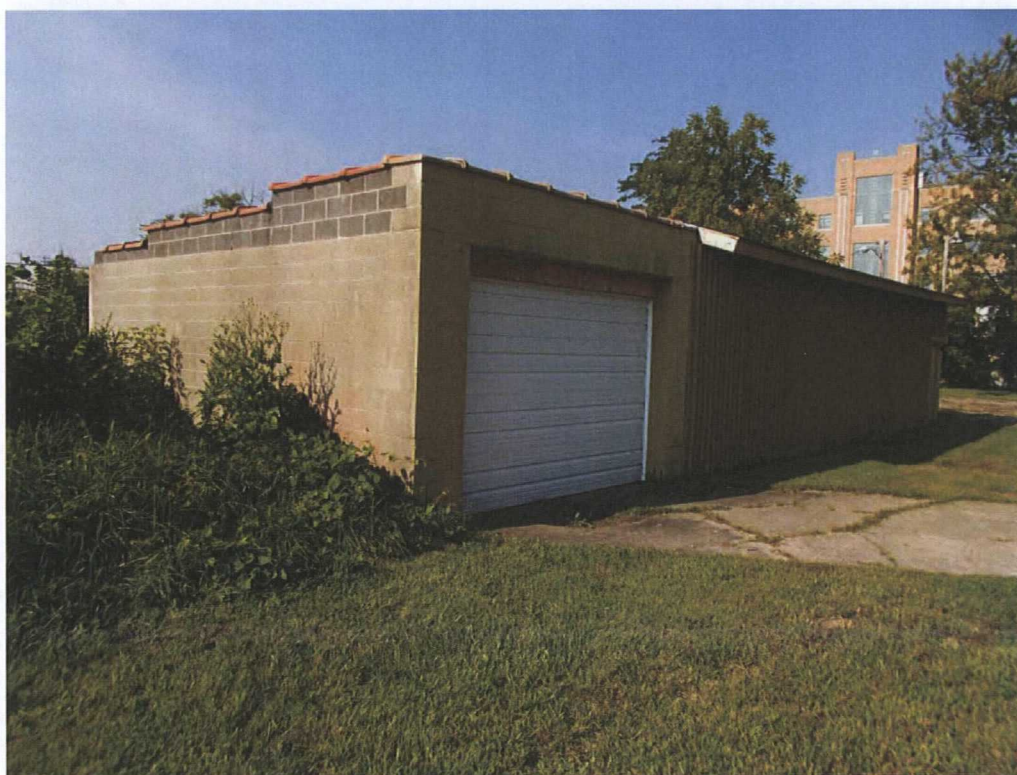
View of the structure from the downstream bank

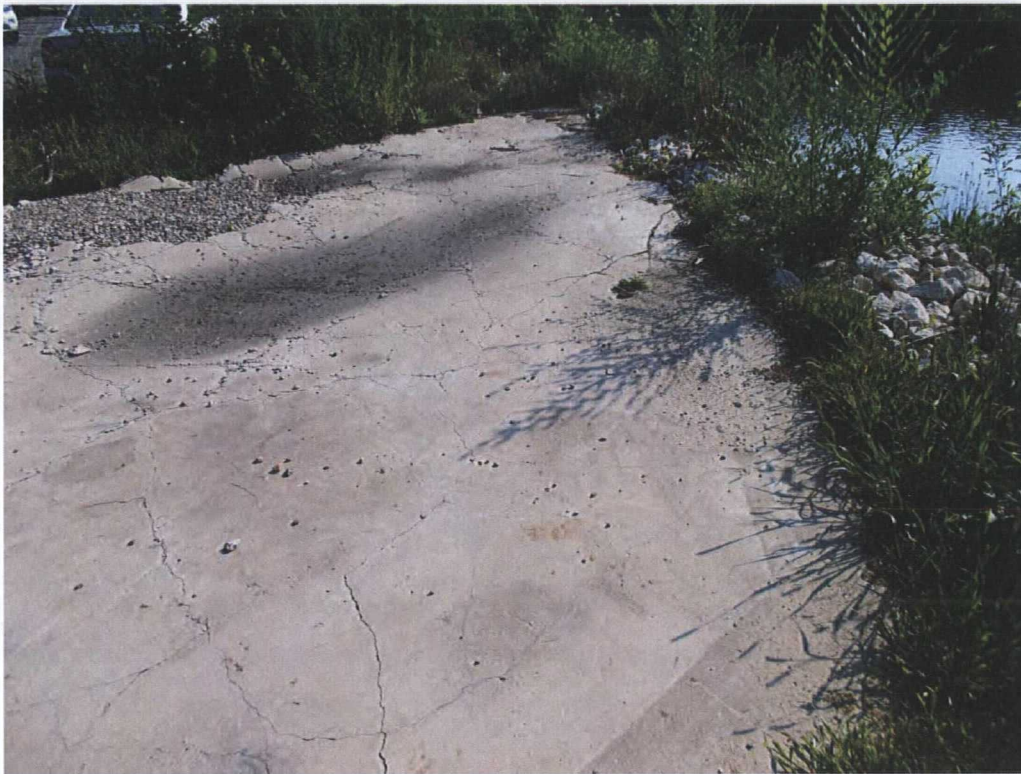
View of slab looking north

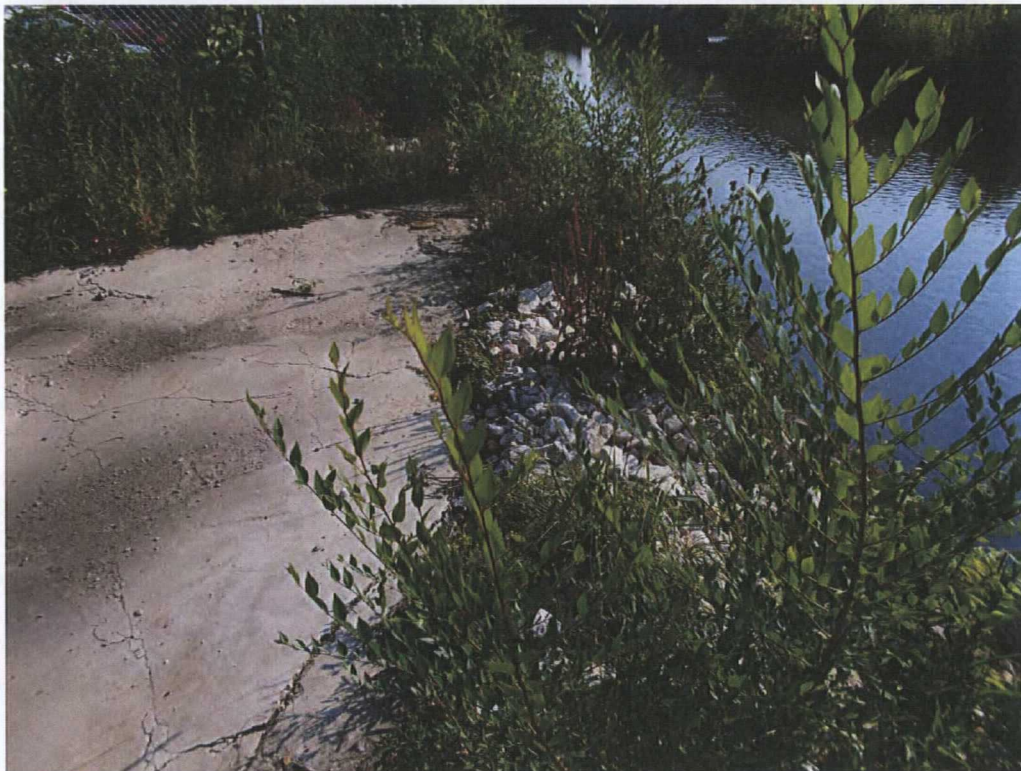
New riprap along east edge of slab

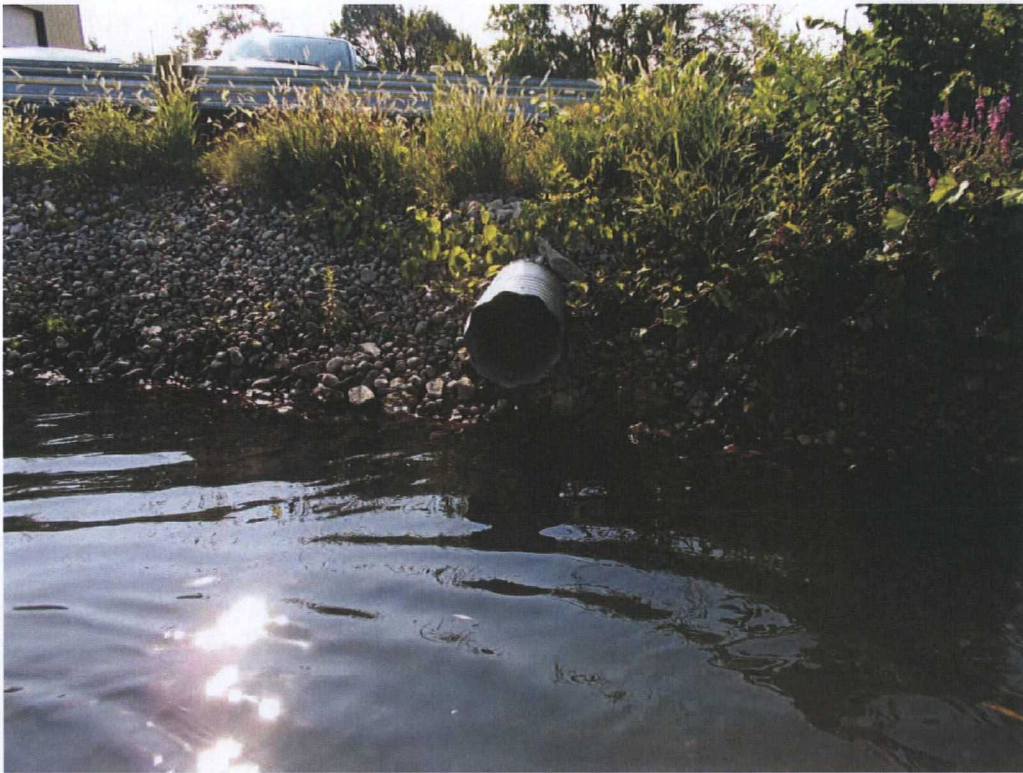
- The outlet has been replaced with a new CMP outlet.

View of new outlet from channel

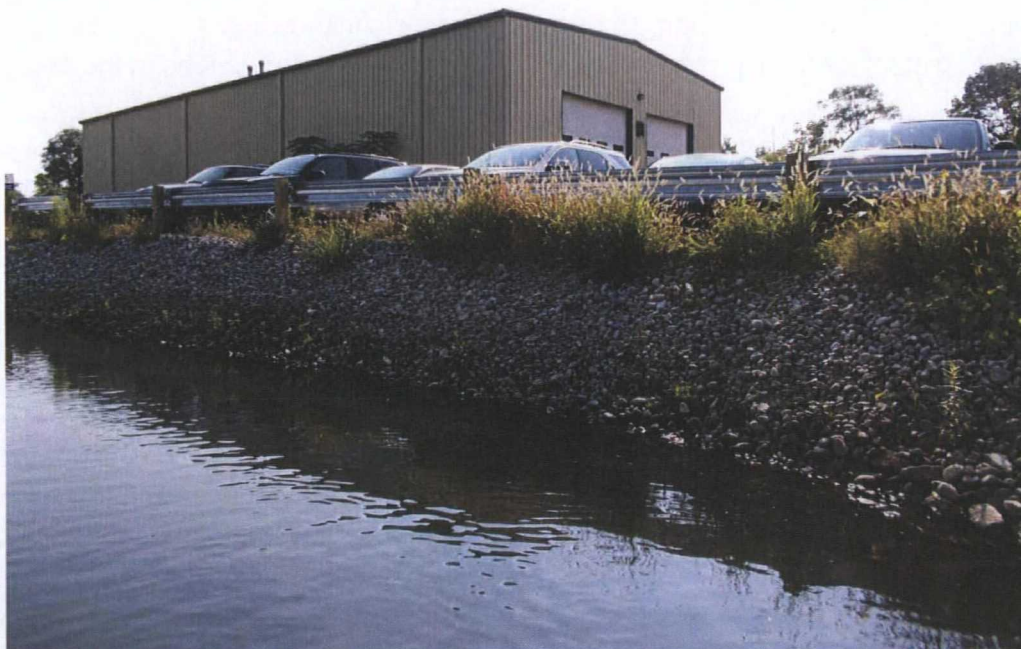
- The structure has been removed and replaced with Type A guardrail. Assuming this is acceptable to the property owner, no additional action is recommended.

View of bank and new guardrail in the area of the previous structure

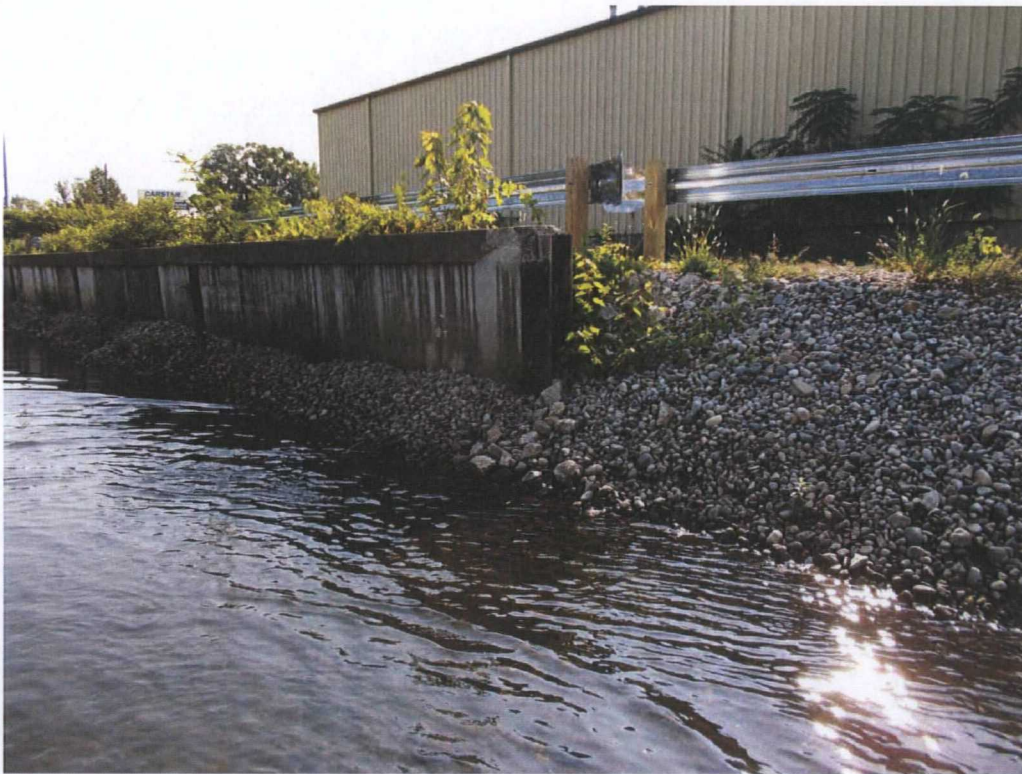
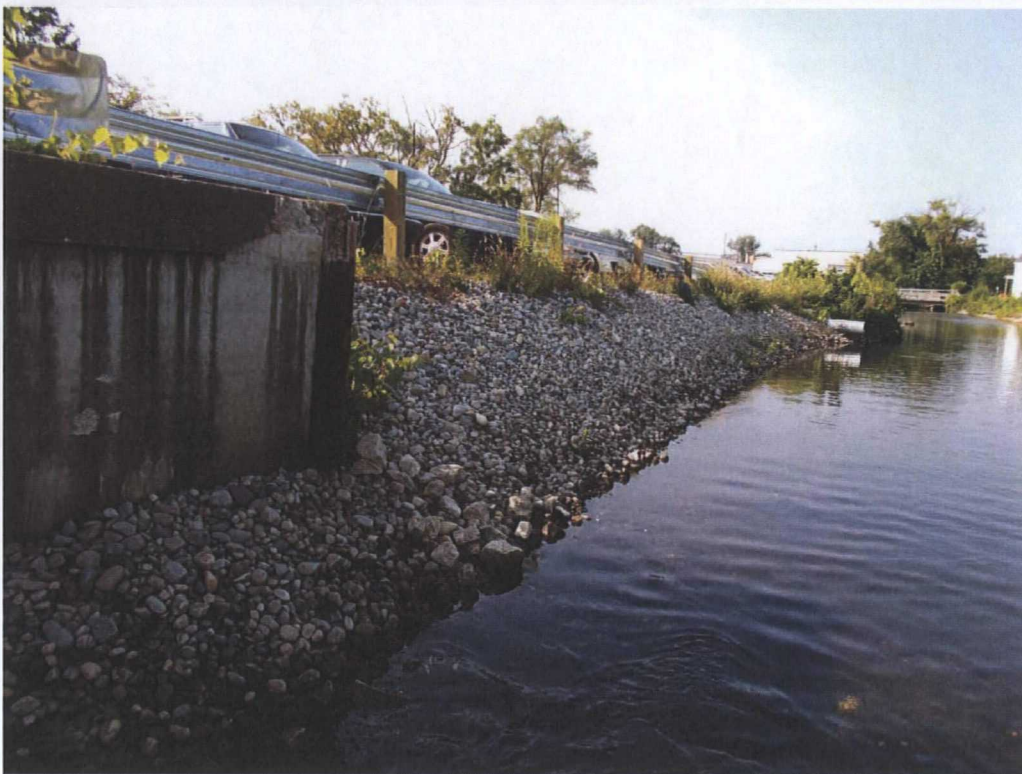
- The failing south end of the structure has been removed and replaced with a stone bank and Type A guardrail. Assuming this is acceptable to the property owner, no additional action is recommended.

View of south end of the structure looking north

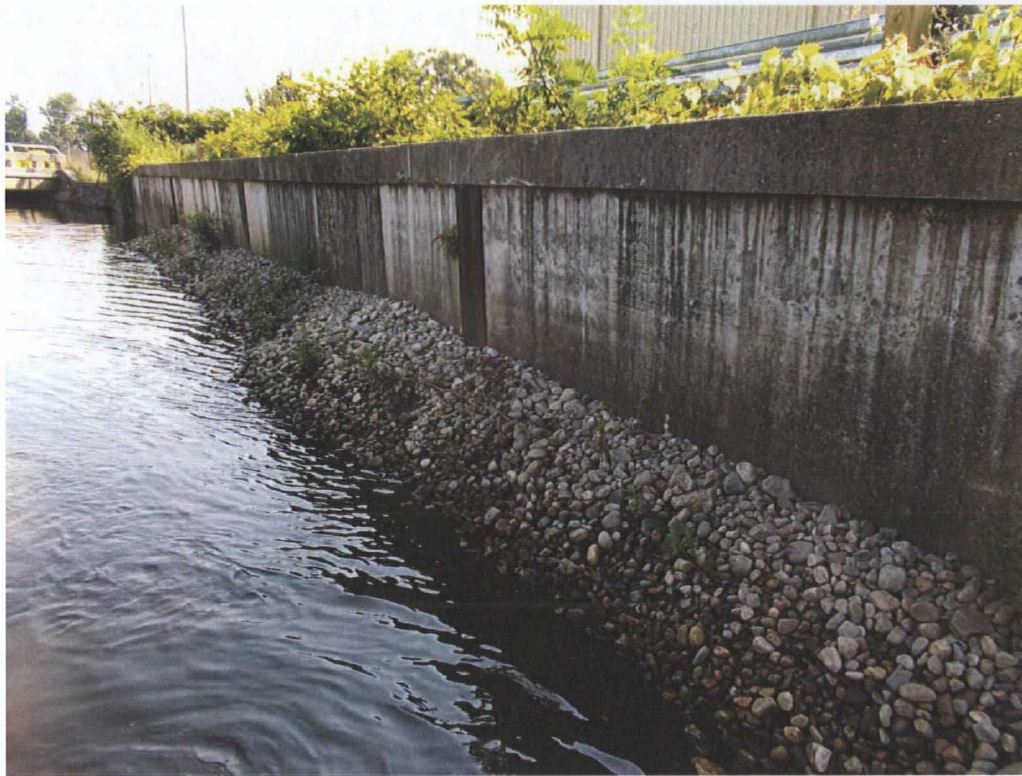
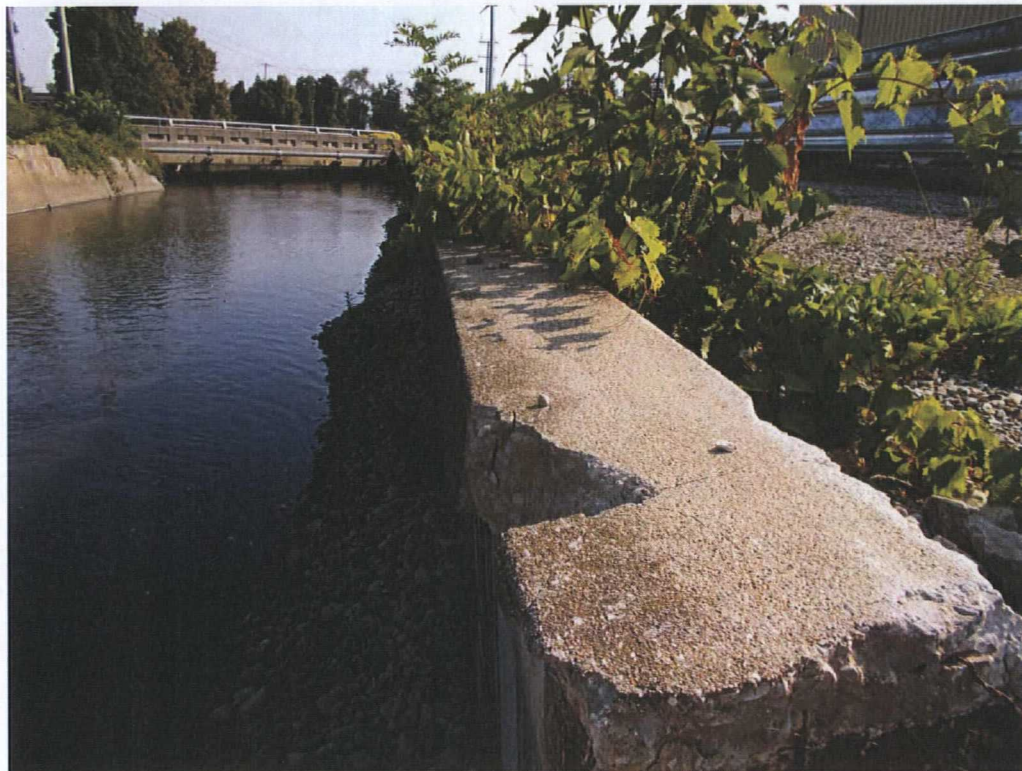
View of the structure looking north

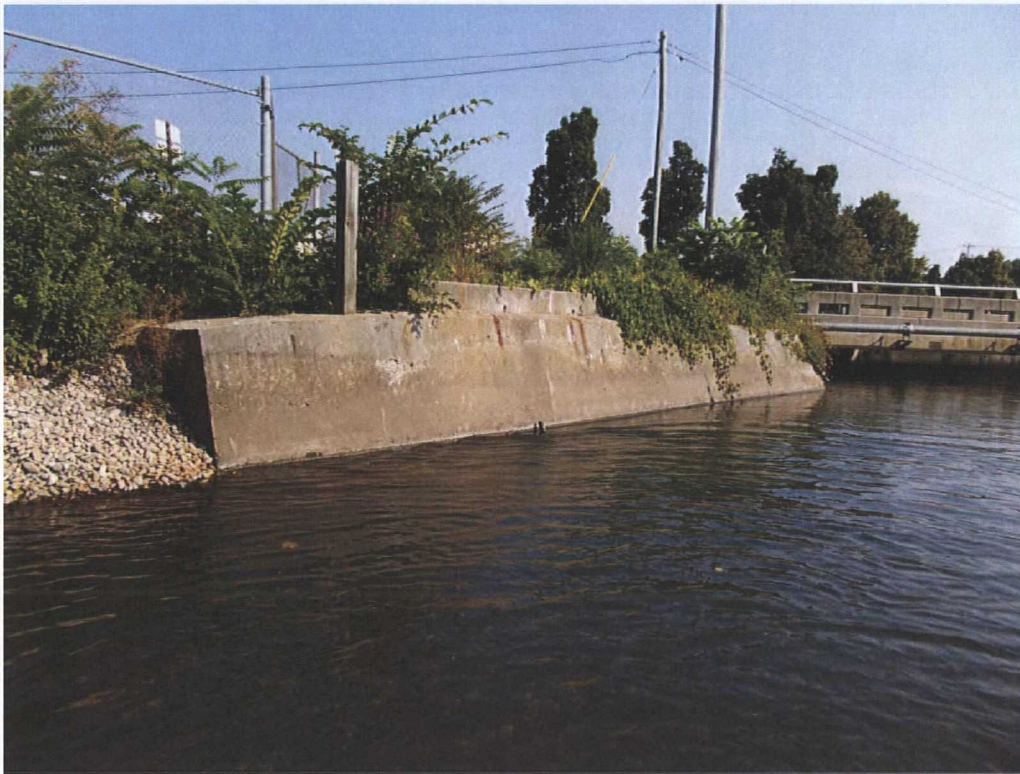
View of the structure from the upstream channel

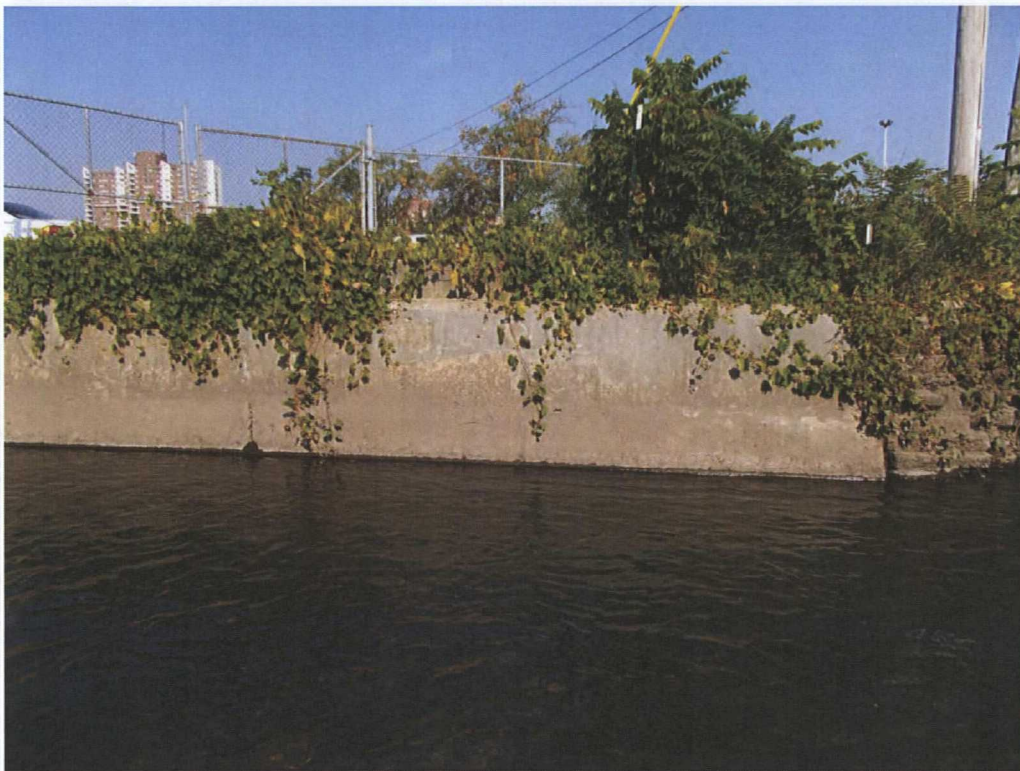
View of the structure from the channel

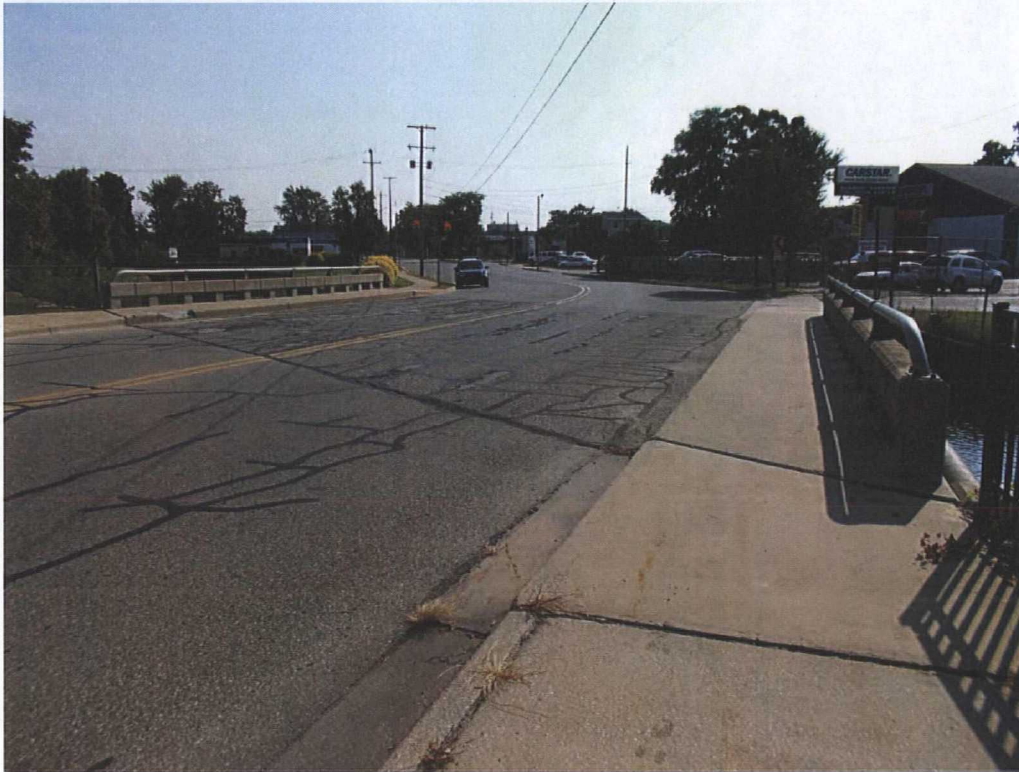
View of structure from southwest approach

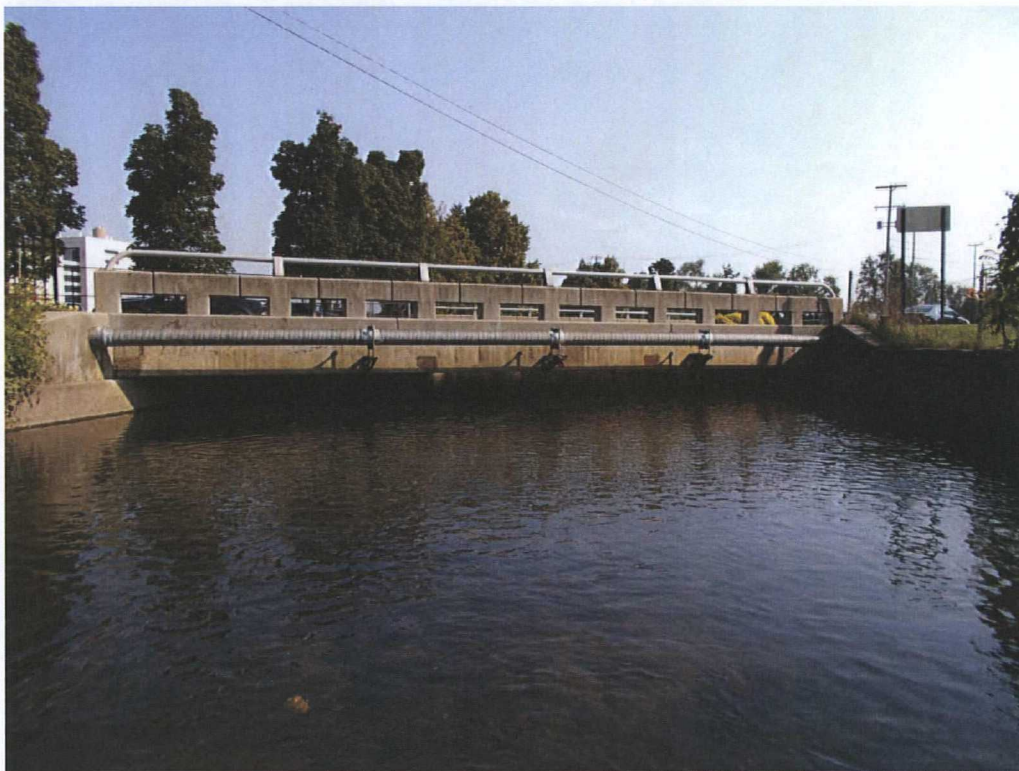
Elevation view of structure from upstream channel
